Massachusetts Department of Environmental Protection
Bureau of Resource Protection – Watershed Permitting Program
Sanitary Sewer Overflow (SSO)/Bypass
Notification Form

Hull, MA WPCF

Unauthorized Discharge Summary 148 Atlantic Ave. Pump Station #1 [08-26-19]

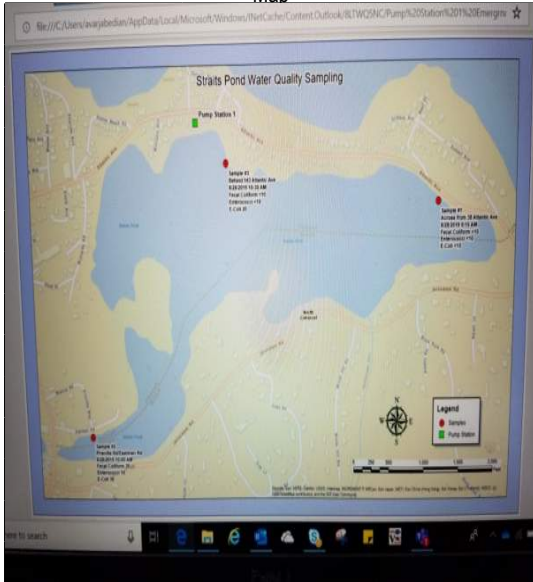
See attached pictures, Supplemental "Unauthorized Discharge Summary" and maps of area. Sampling results
noted on the map of Straits Pond.

Map of Straits pond and sampling locations

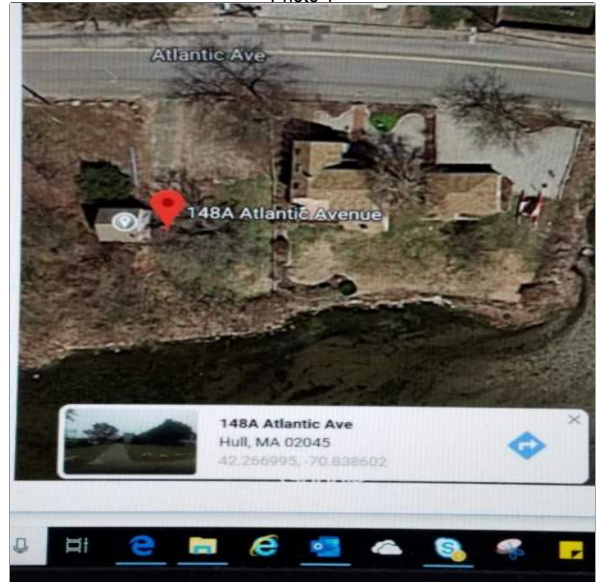
Photo 1

Pump Station #1

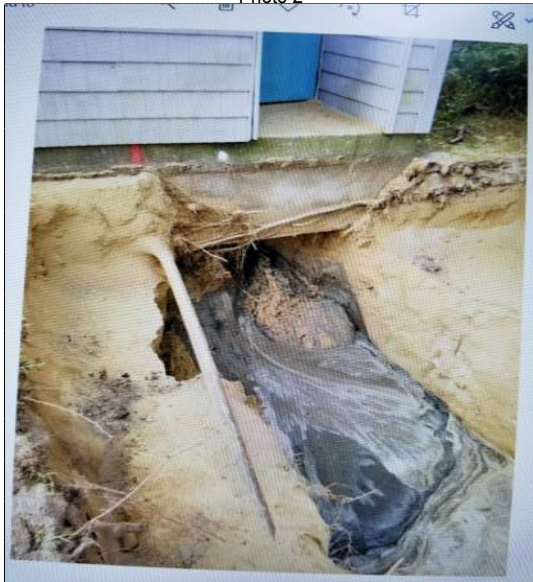
Photo 2

Initial trench excavation at PS1

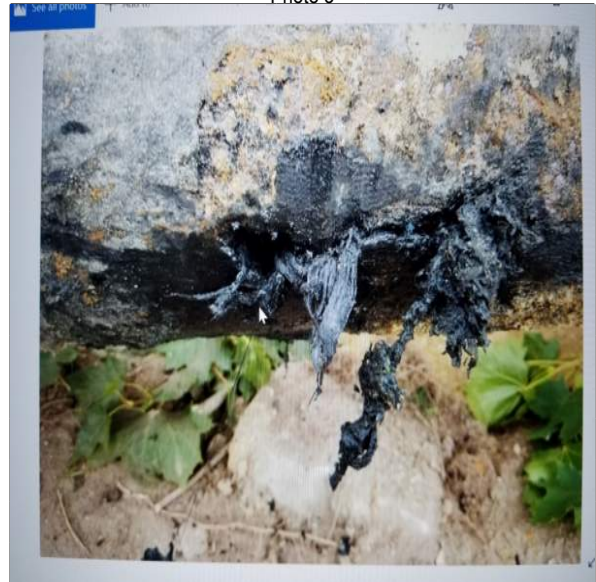
Photo 3

Specify: 8" ductile iron force main pipe corroded and leaking back into pump station.

Corroded pipe segment

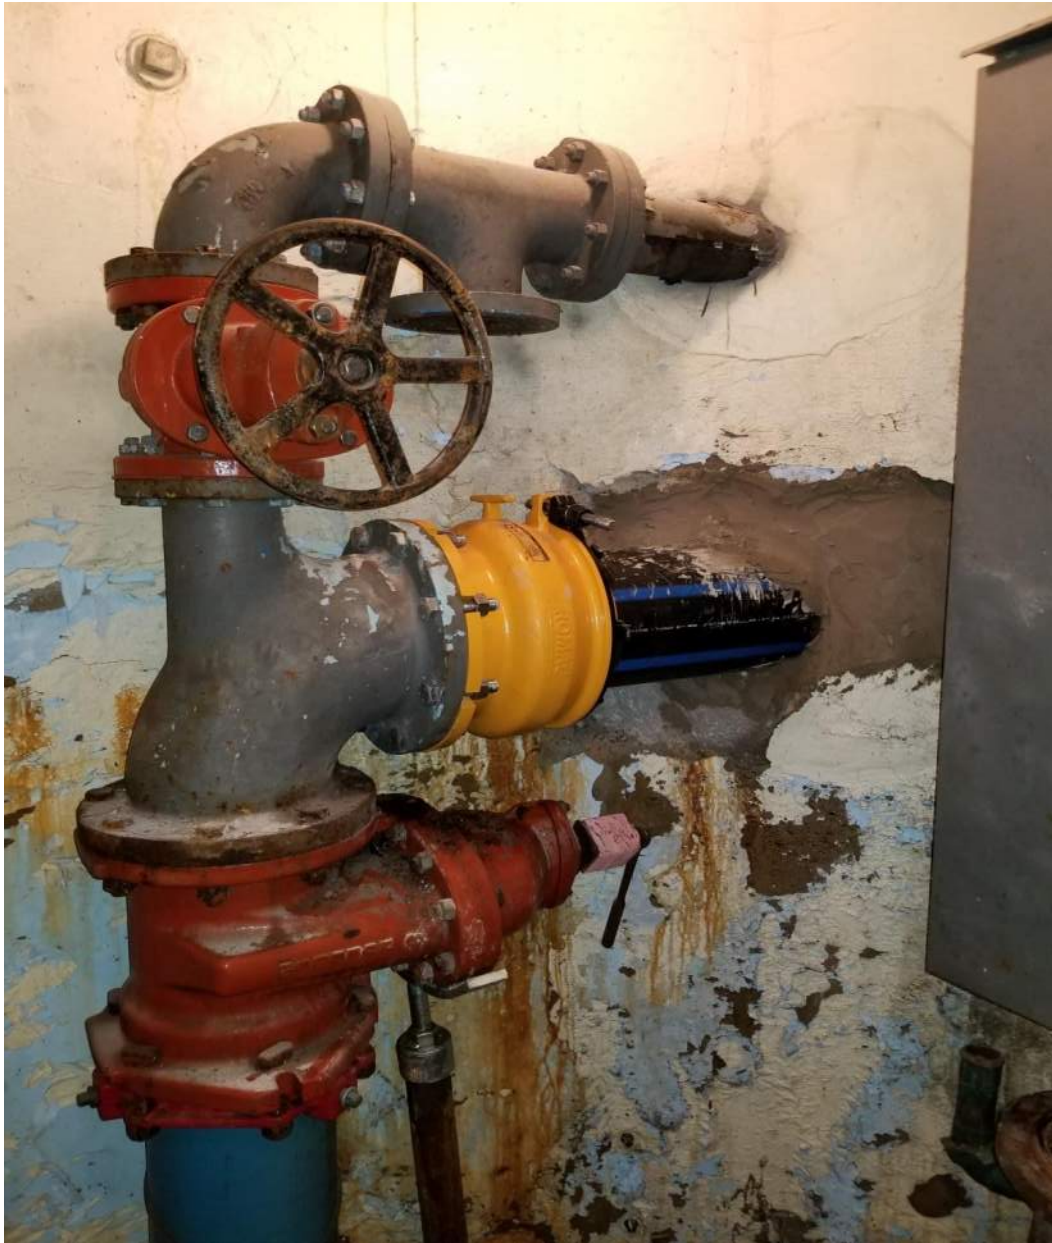
New HPDE pipe coupled to existing discharge pipe inside pump station

Plant staff saw very small leak as early as Thursday 8/22 but unconfirmed source through 8/25. Monitored
pump station daily [several times] and surrounding area with no break out seen. The Force main was shut
down. while emergency repairs made by Aqualine Utility on Wed 8/28. A new 12 foot HDPE pipe section was

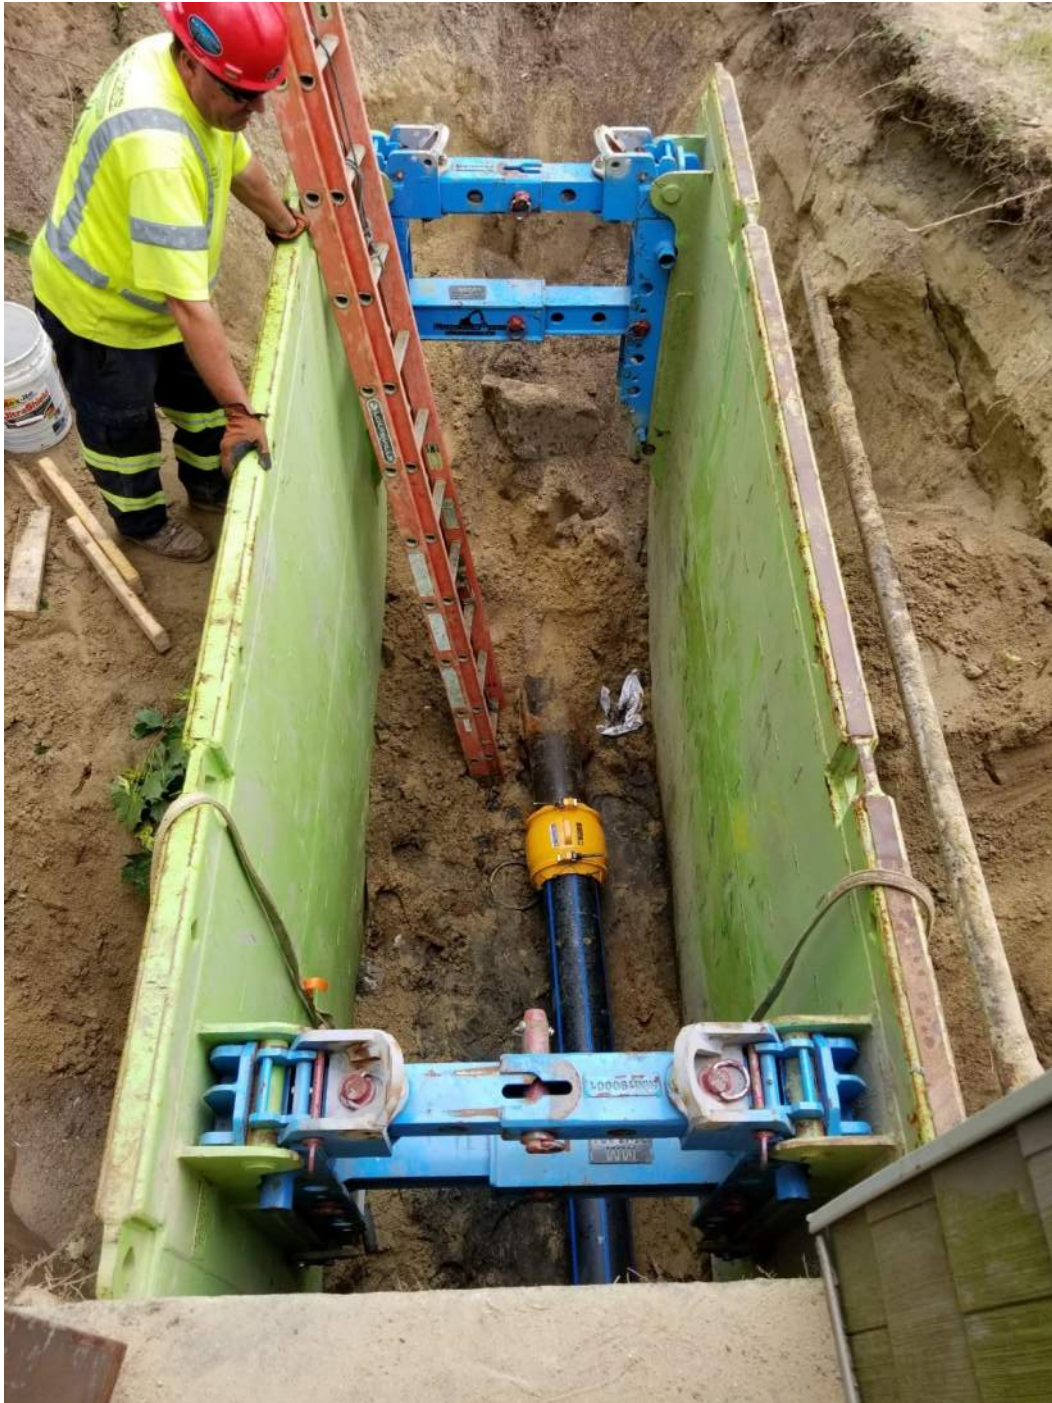
New 12 ft HDPE pipe section coupled to existing DI force main pipe

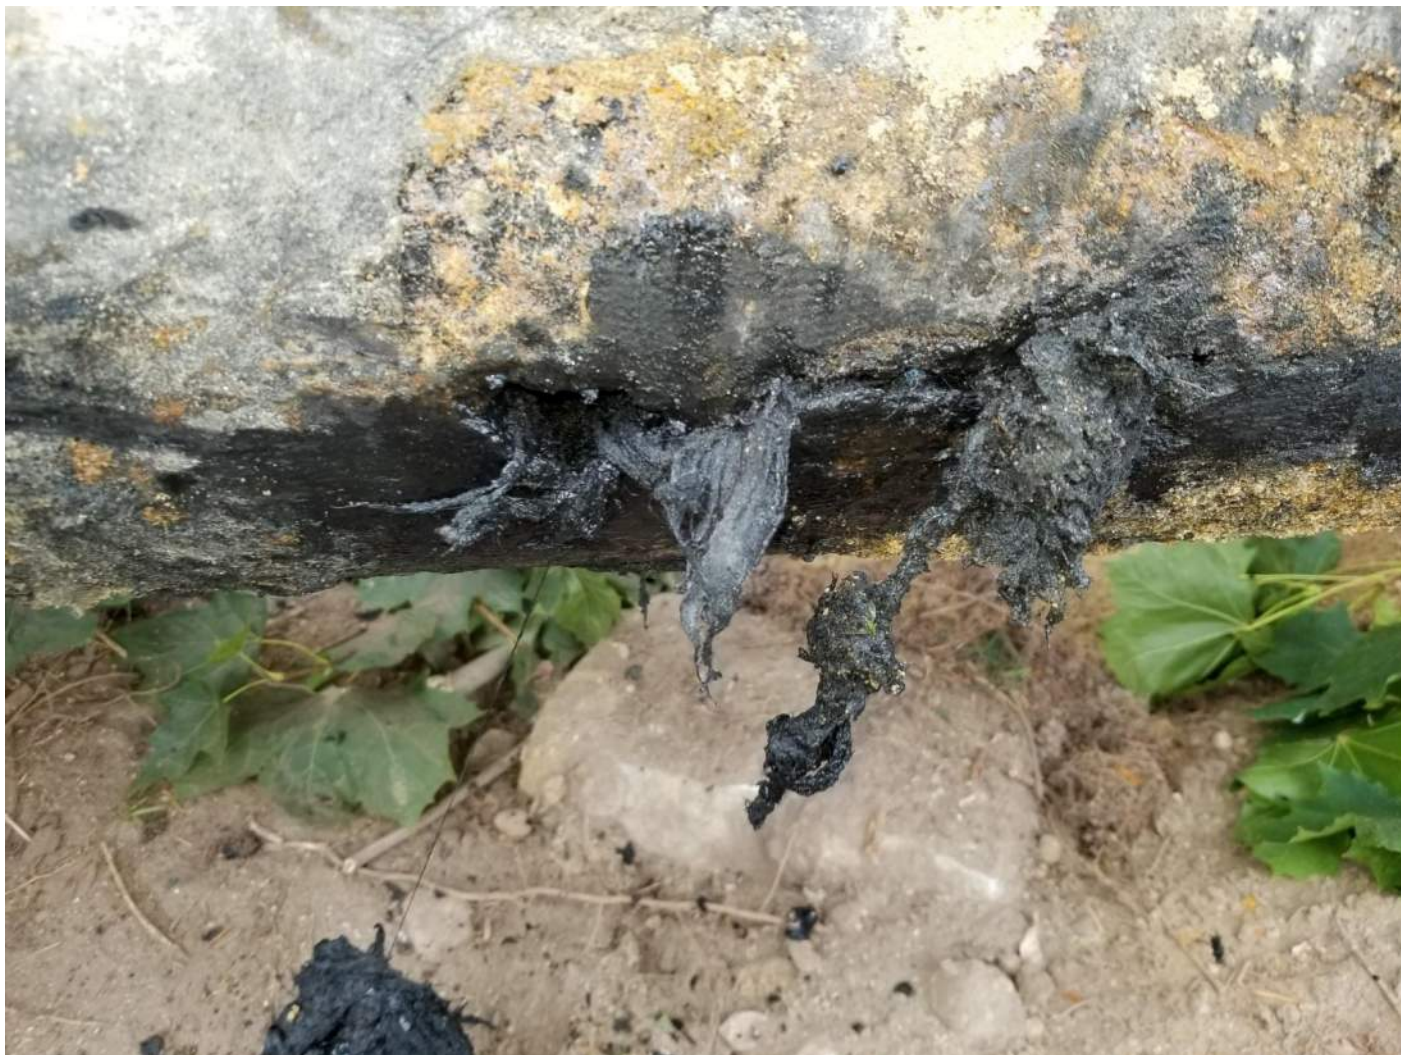
Specify: 8-inch force main was rotted very close to pump station building. Sewage was leaking back into building pump room,
and the sump pump was pumping this liquid back I to the wetwell.

Failed 8-inch DI force main pipe approximately 2-3 feet out from pump room wall and under building

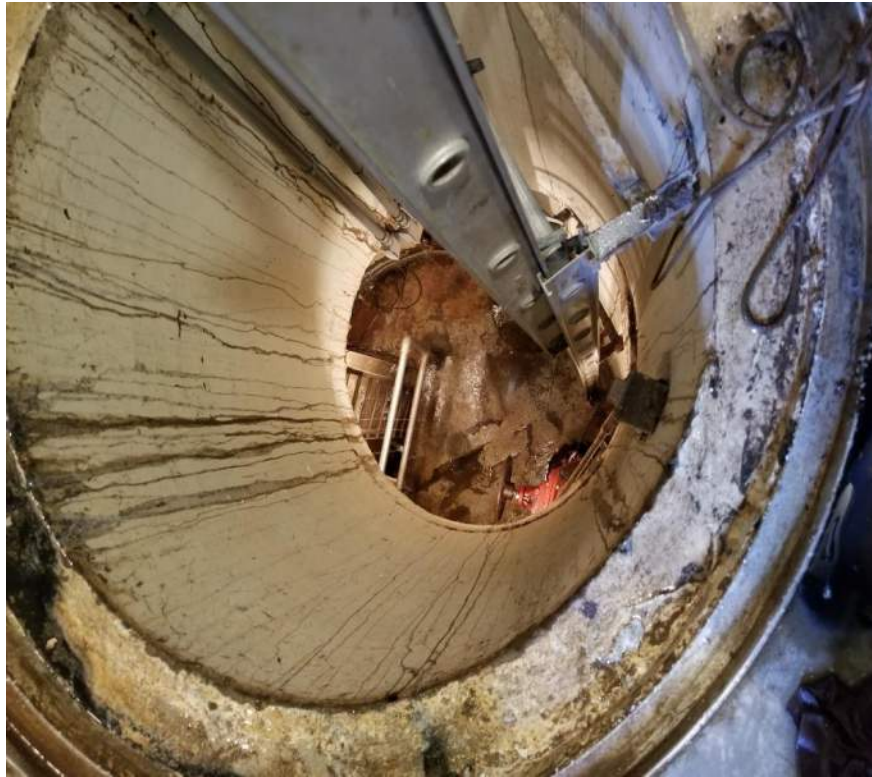
Leak contained in the immediate trench, and previous leakage entered pump room and captured and then
pumped into the wet well.

Leakage into pump station mid-level [looking down from top level]
